**LOUISIANA DEPARTMENT OF ENVIRONMENTAL QUALITY
INTRA-AGENCY ROUTING FORM**

Incident ID:186150

**SUMMARY OF DIESEL SPILL
FLORIDA AVENUE CANAL
AUGUST 1-9, 2018
FINAL REPORT**

E.A.D. INVESTIGATOR'S REPORT
ADDENDUM

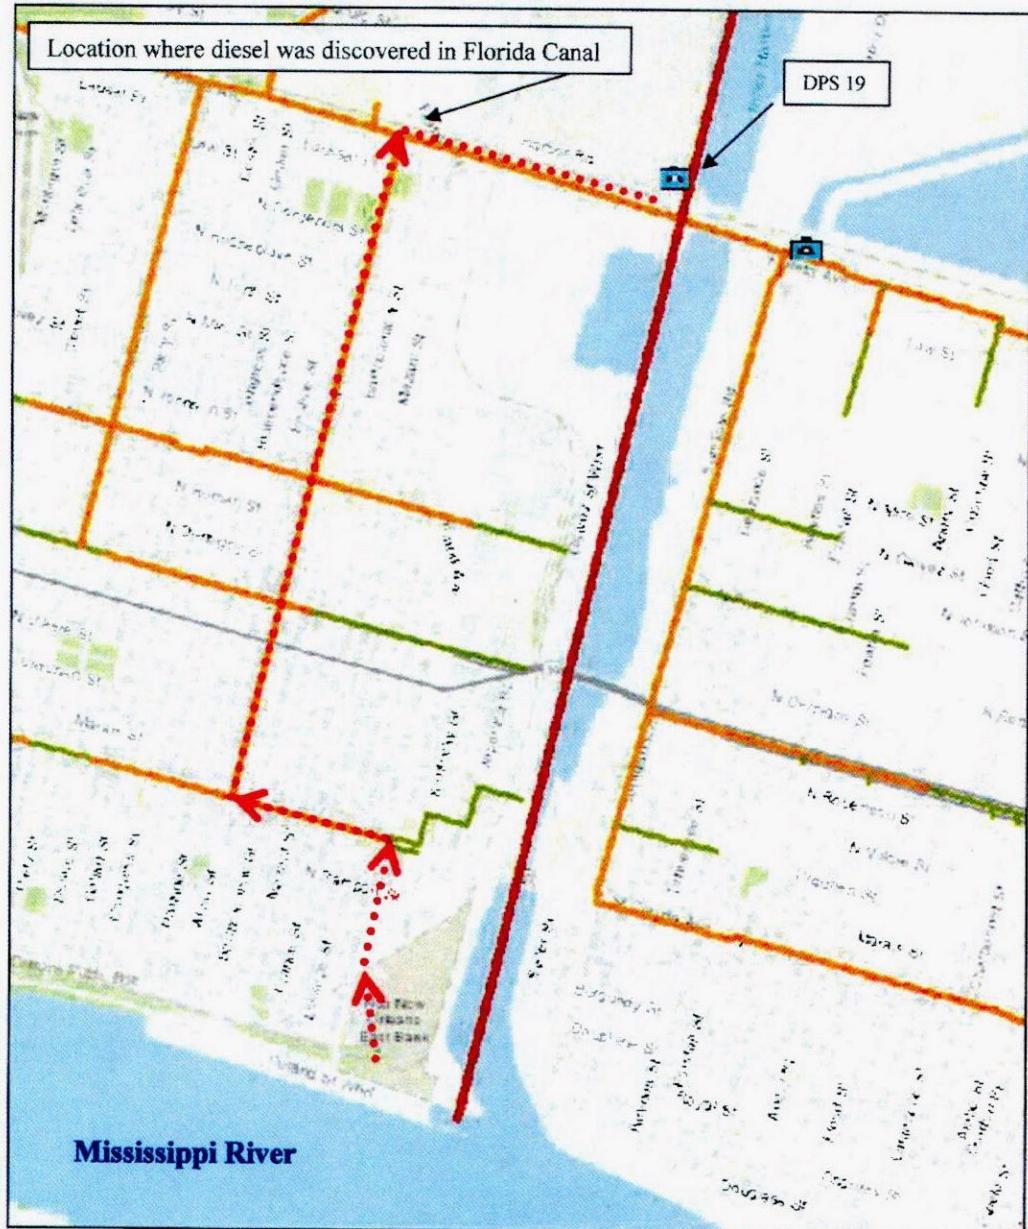
Diesel Spill Path in Drainage

..... Path of Diesel in Drainage

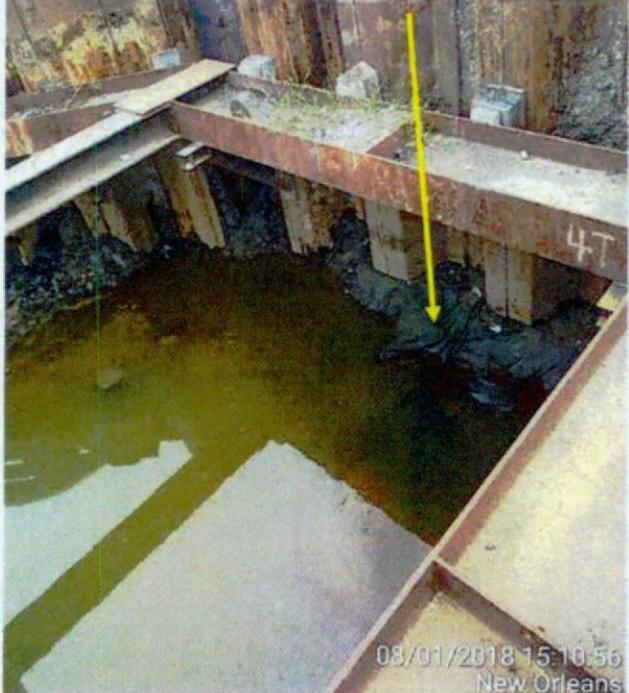
Outfall of Alvar box culvert into Florida Canal where the diesel made its first appearance

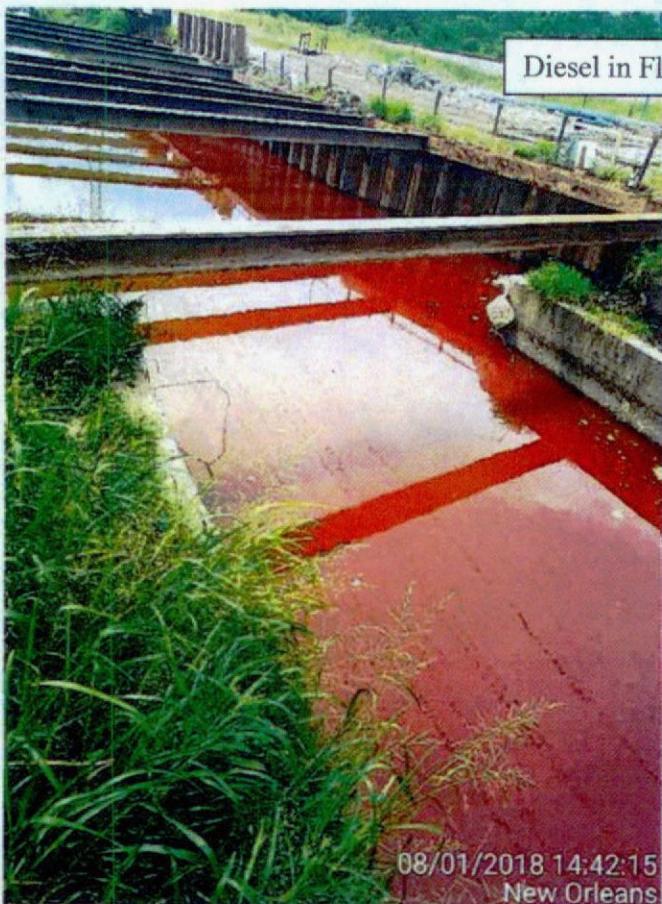
Diesel in Florida Canal

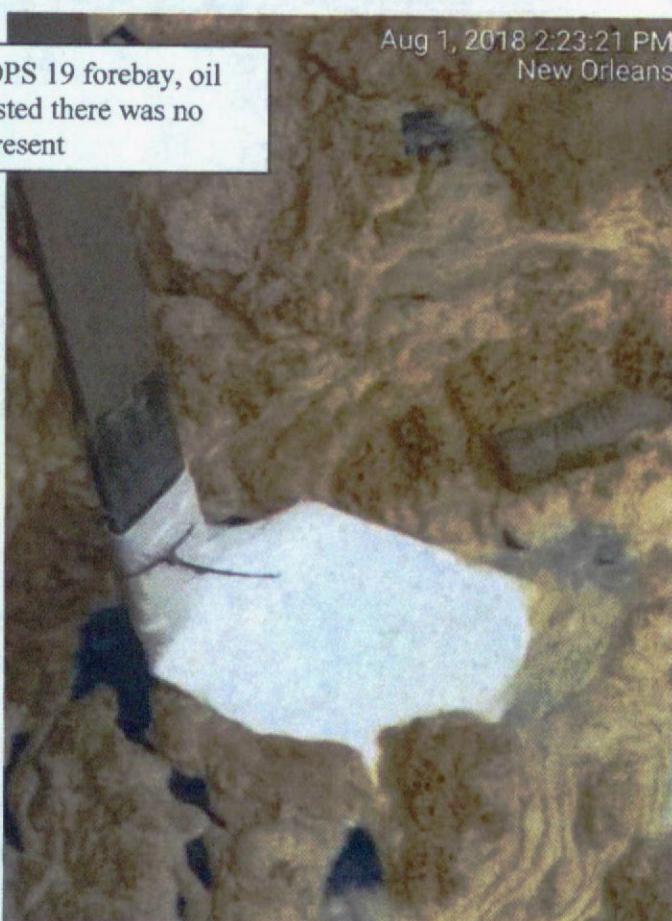
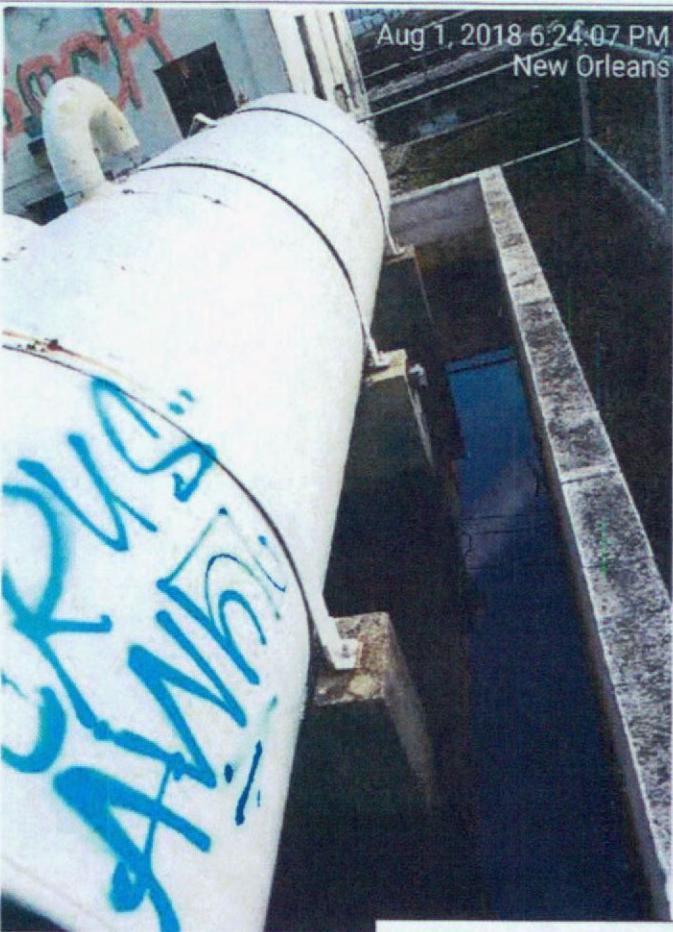
08/01/2018 14:39:38
New Orleans

Diesel in secondary containment at source site

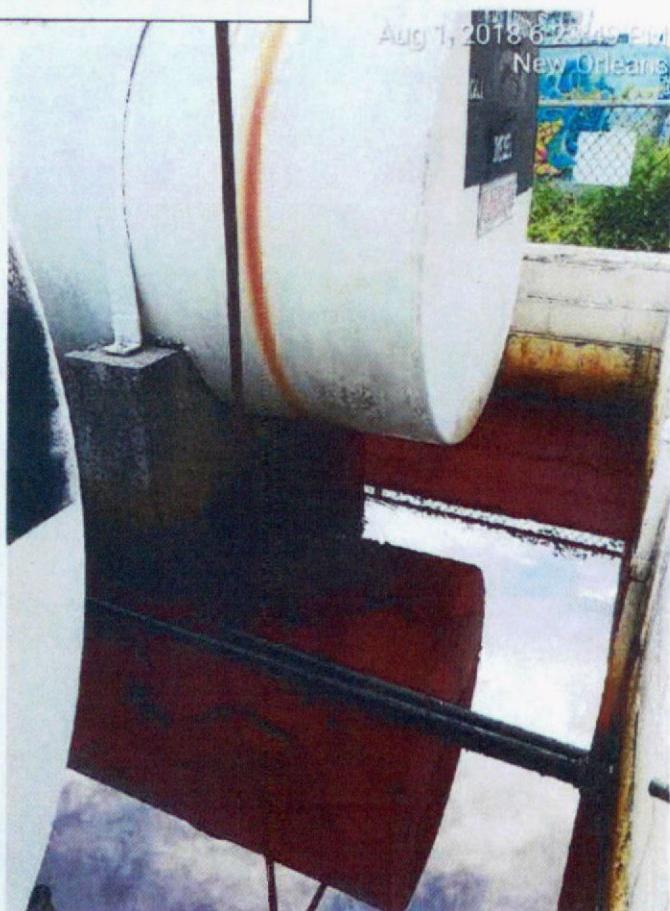
Trespassers scrapping material from the abandoned Naval Base on Poland Avenue removed brass plugs from the bottom of two roughly 2000 gallon storage tanks which emptied their contents into non-watertight secondary containment, then into the drainage system and eventually to the Florida Canal and Drainage Pump Station 19. None of the product was discharged past the drainage pump station.

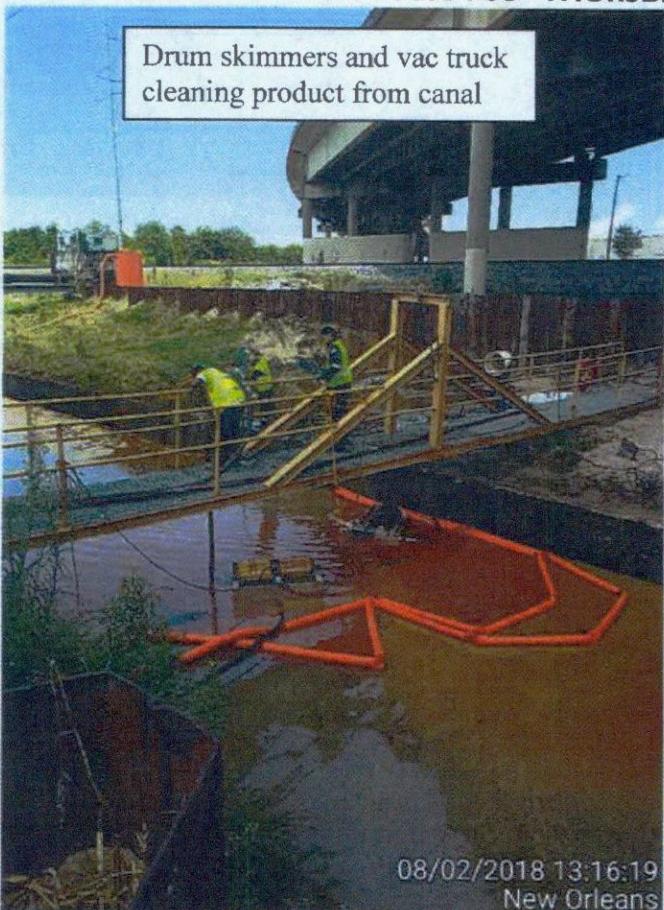
Drum skimmers and vac truck
cleaning product from canal
